ANALYSIS AND RESTORATION OF AN ITALIAN CASSONE C. 1400

By Richard Higgins

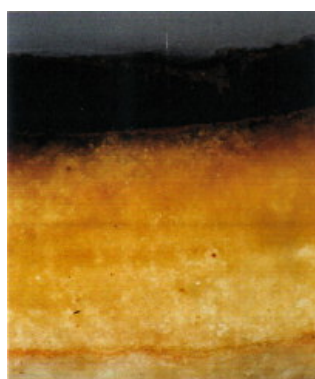
SAMPLE 1.

Showing the coarse gesso at the bottom, followed by the finer material above it in several coats.

The yellowish colour is partly due to staining from paint and varnish, and partly due to glue content.

The brown restoration at the top is sinking deep into cracks in the original decoration.

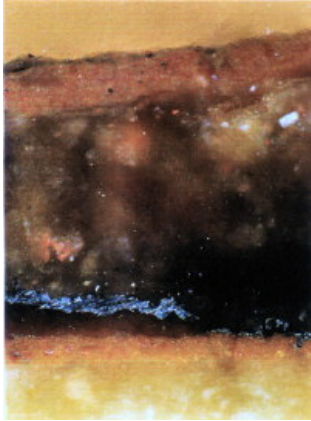
SAMPLE 1.

Sample 1 shows the remains of silver leaf over a preparatory layer of reddish clay. The silver probably once had a coloured glaze over the top. The glaze is now dark brown and the metallic leaf has oxidised to black silver oxide.

At the higher magnification showing the oxidised silver leaf, resting on a reddish clay.

Above the silver is a degraded glaze layer, and over that is brown overpaint.

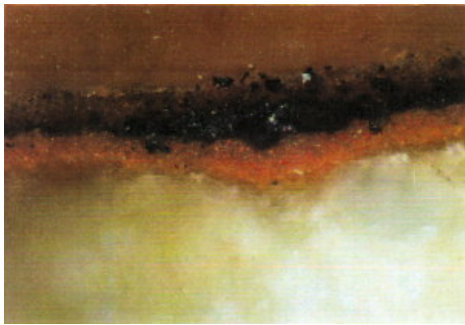
SAMPLE 2.

Sample 2 has the same red clay as in sample 1, however there is no metal leaf visible.

The same reddish clay as in sample 1, but the black over the top has the characteristics of charcoal black.

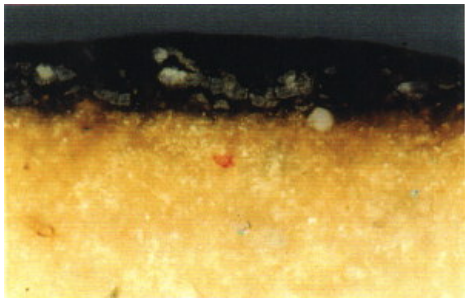
SAMPLE 3.

There is no restoration on this fragment, but the original decoration has become very dark.

The whiteish particles are based on lead, and may be lead white, but traces of tin detected by the SEM suggests that it could be lead tin yellow.

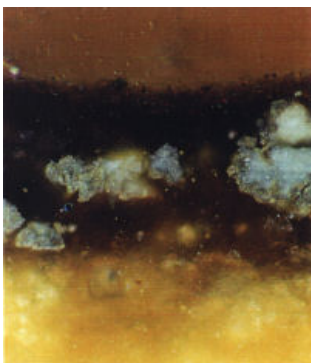
SAMPLE 3.

Sample 3 contains particles of a lead pigment - either lead white or lead tin yellow - suspended in a translucent brown oil layer which may once have been coloured. The lead pigment has degraded, forming a grey layer on the outer surface; it has probably been reduced to lead sulphide.

At higher magnification one can see that the outer edges of the lead pigment particles have oxidised and gone grey.

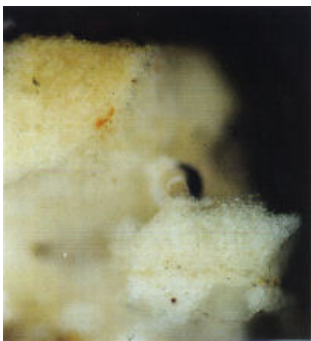
SAMPLE 4.

In this rather broken fragment there are just the gesso layers, with a few brown particles on the surface.

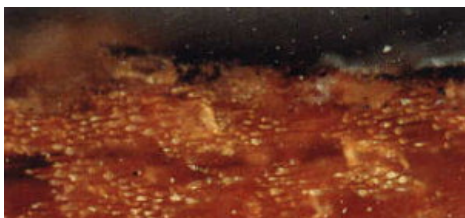
SAMPLE 5.

Surface of the wood with traces of gesso and paint.

The gesso is very thin compared to the layers seen on the other samples, and what one sees here is probably a damaged area.

The gesso is the same calcium sulphate found in all the fragments.
