CRAMPING OF RISEN TABLE TOP VENEER

By Michael Barrington

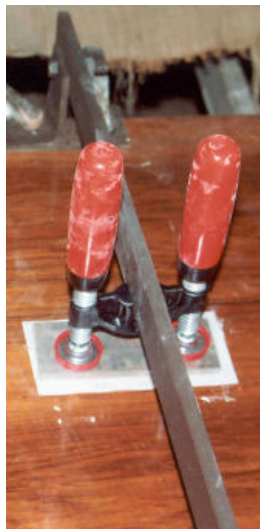
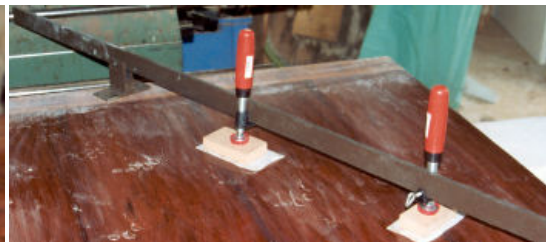
The majority of the bubbled areas were outside the reach of even the deepest throated cramps, so we had to make special bridges. In any case whatever cramping method we used had to cater for multiple areas of simultaneous cramping because time was not on our side. I bought a mixture of a dozen single and double cramp heads and made up two steel bridges of 6ft and 8ft. These could be cramped to the edges of the leaves at almost any angle to carry cramp heads. The cramps themselves were almost certainly of Far Eastern origin, strong but badly made in that their slots were not machined but cast with rounded throats, which prevented the cramps from standing vertically under the bridge bars. All the cramp slots had to be machined accurately in a milling machine which took some hours but was successful.

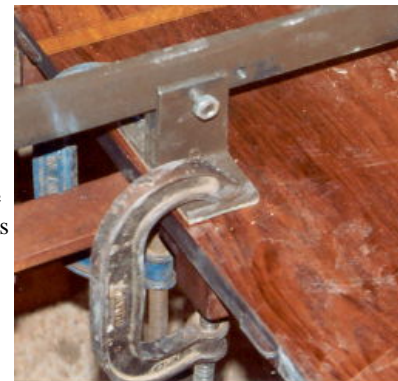
The steel bridge bars were of 40mm x 10mm black mild steel with double angle-iron "T" stands bolted to each end. One stand on each bar could be repositioned wherever it was needed. The stands were riveted together and the undersides were faced with cork and goat skin to protect the table. They were cramped to the table edges with a pair of G cramps with the bars at

angles convenient to position cramps over the damaged areas. We used up to four cramps on a bridge bar at a time.
