THE USE OF PAINT ANALYSIS TO AID IN THE RESTORATION OF A 17TH CENTURY ITALIAN PAINTED FRAME

By Lucinda Compton

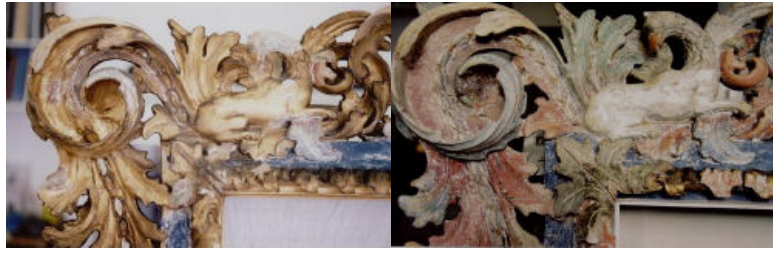
Small sections of carving were missing, the joints loose and some worm damage. The whole frame was coated in layers of gesso and gilded. The gold had a thick layer of black surface dirt, typical of this previously industrial area of Yorkshire, and there were large areas of detached gesso.

All loose breaks and joints were glued up and supported from behind with canvas and size. All wormholes were treated and filled with glue and sawdust mix so fresh holes can be identified in future (time 10 hours). The hanging attachments were removed and refitted securely. Missing areas of carving were replaced using lime (time 24 hours).

In some areas the gesso and gilt were removed manually by dry-scraping with a Tiranti spatula. This was especially effective above the indigo painted slip frame where the thick layers of loose pigment had prevented the gesso from forming a strong bond. Other areas were extremely stubborn and care was needed to preserve the original paint. The oil gilding was removed with Nitromors. The deep layers of clay and gesso were removed by softening with water soaked papier-mâché, in gradual controlled stages. This was complicated by a huge variation in the thickness of the gesso, and random patches of white lead-based paint.

The loose pigments were consolidated with a barrier layer of Paraloid B72 in toluene.

Areas of bare wood were gessoed and smoothed to match existing thicknesses and then decorated to match the original paint using pigments (as per the analysis) in gum arabic. A thin coat of microcrystalline wax was applied (time 206 hours).

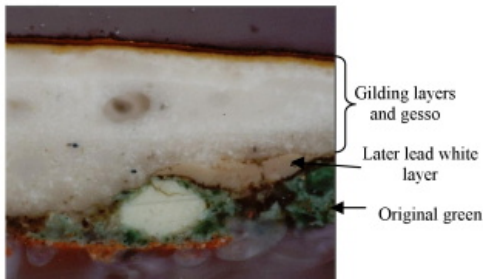
Red lead primer. Original green overlaid by thick gesso and then oil gilding. A trace of plain lead white paint over the green at the right end of the section suggests the frame may have been painted more than once, and that it was cleaned down before the gilding took place. X 200 magnification

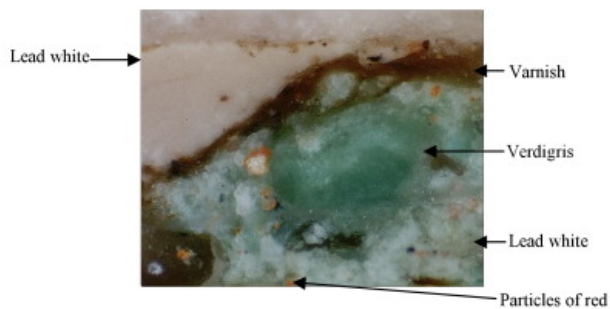
Detail of the green, showing the thick varnish on top, followed by the remains of a white oil paint layer which may have been a second scheme. X 500 magnification.

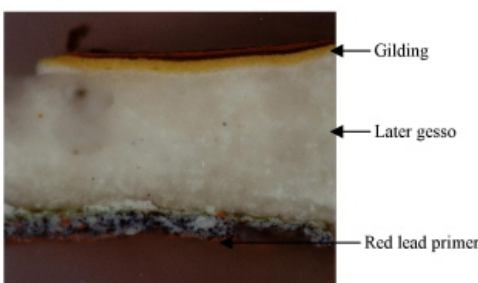
A thin layer of red lead under the purple/blue. X 200 magnification.

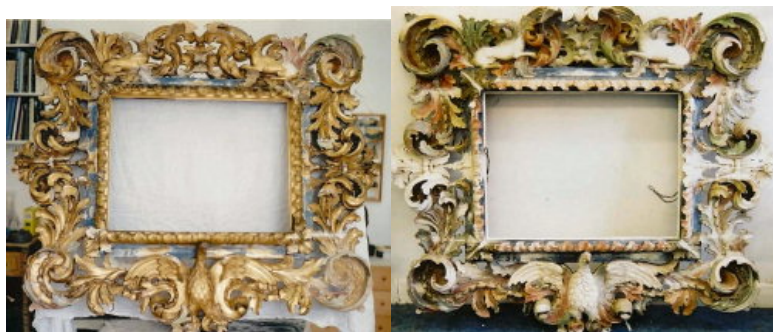
The original colours are wonderfully vibrant and the whole frame is decorated with highlights, lowlights, veins and shading on the leaves, etc. It is a truly stunning and rare frame.
