ANALYSIS AND RESTORATION OF AN ITALIAN CASSONE C. 1400

By Richard Higgins

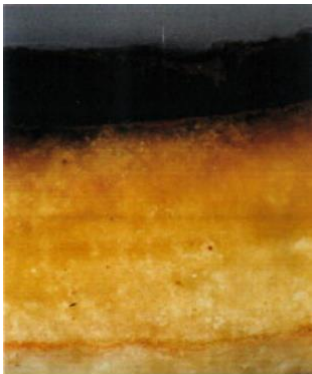
SAMPLE 1.

Sample 1 shows the remains of silver leaf over a preparatory layer of reddish clay. The silver probably once had a coloured glaze over the top. The glaze is now dark brown and the metallic leaf has oxidised to black silver oxide.

Over the top of sample 1 is a coat of red/brown paint. This is resting over degraded varnish and therefore cannot be original. The pigment is an iron oxide of natural origin, of which we are unable to determine the date..

Showing the coarse gesso at the bottom, followed by the finer material above it in several coats.

The yellowish colour is partly due to staining from paint and varnish, and partly due to glue content.

The brown restoration at the top is sinking deep into cracks in the original decoration.

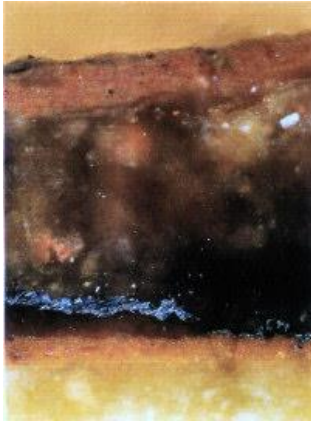
SAMPLE 1.

At the higher magnification showing the oxidised silver leaf, resting on a reddish clay.

Above the silver is a degraded glaze layer, and over that is brown overpaint.

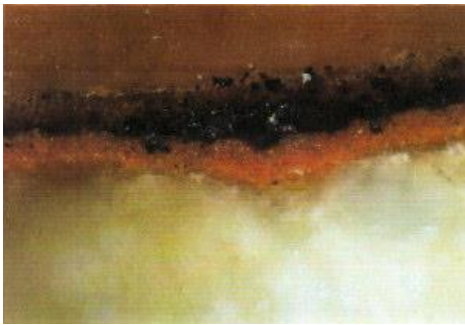
SAMPLE 2.

Sample 2 has the same red clay as in sample 1, however there is no metal leaf visible.

The same reddish clay as in sample 1, but the black over the top has the characteristics of charcoal black.

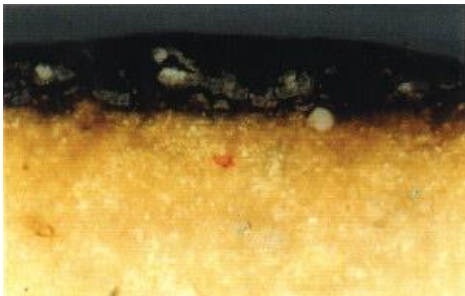
SAMPLE 3.

Sample 3 contains particles of a lead pigment - either lead white or lead tin yellow - suspended in a translucent brown oil layer which may once have been coloured. The lead pigment has degraded, forming a grey layer on the outer surface; it has probably been reduced to lead sulphide.

There is no restoration on this fragment, but the original decoration has become very dark.

The whiteish particles are based on lead, and may be lead white, but traces of tin detected by the SEM suggests that it could be lead tin yellow.

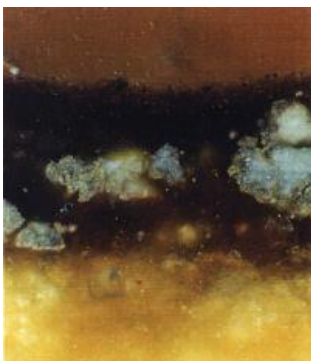
SAMPLE 3.

At higher magnification one can see that the outer edges of the lead pigment particles have oxidised and gone grey.

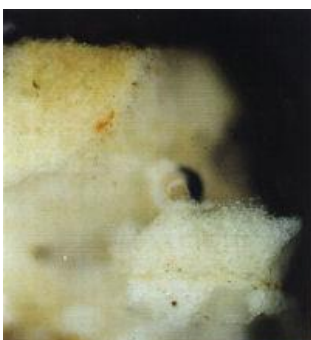
SAMPLE 4.

Samples 4 and 5 retain no trace of the early decorative finish, but the gesso layers are the same.

In this rather broken fragment there are just the gesso layers, with a few brown particles on the surface.

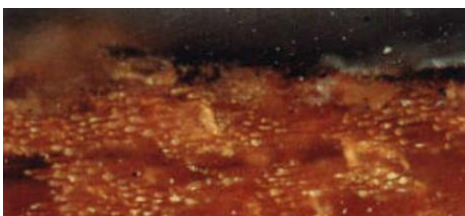
SAMPLE 5.

Surface of the wood with traces of gesso and paint.

The gesso is very thin compared to the layers seen on the other samples, and what one sees here is probably a damaged area.

The gesso is the same calcium sulphate found in all the fragments.
