**RESTORATION REPORT FOR
THE GRAND MASTER'S THRONE
AND A PAIR OF WARDEN'S
CHAIRS
PROPERTY OF THE UNITED
GRAND LODGE OF ENGLAND
By Ray Dudman
a BAFRA Accredited Member**

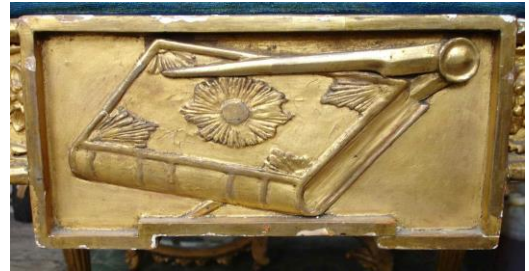
The existing visible gilt finish was a mixture of oil and water gilding, probably carried out in the late 19th Century. This had been laid onto a prepared gesso base, which had been applied over previous water gilding and gesso. Much of the oil gilding had perished and was in poor condition. It had been repaired with more oil gilding and a clear lacquer had been applied to brighten up the appearance.

There were a number of previous gilding schemes beneath the visible finish and scrape tests were made to establish these layers. It was clear that the original surfaces remained although little or no gold could be found.

The culmination of so many layers of gilding and gesso had obliterated the carving, especially over the areas of finer detail.

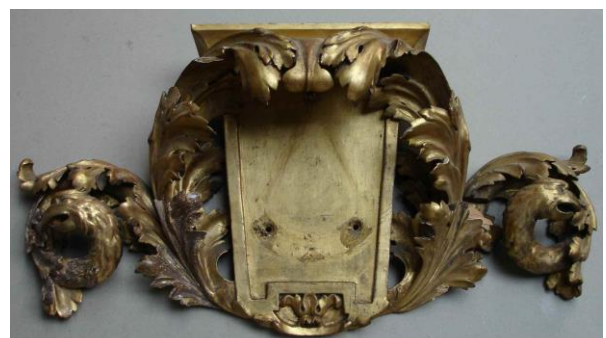
There were many unsightly repairs that had been made with composition. This included leaf work on both front rails on the Warden chairs and many of the paterae

around the seat rails of the throne. The leafwork on the central cresting had missing elements including the central turnover and there was generally damage to many areas.

We therefore, agreed that the only option was to remove all the overlayers from the remaining original gilded surfaces, remove all previous unsightly composition repairs and replace with newly carved lime wood to match the original elements. Repairs to the gesso would then be carried out and due to the fact there was little or no gold remaining, we would completely re-lay the original surfaces with gold leaf. The new gold would be left fairly bright rather than re-creating an old antique appearance.

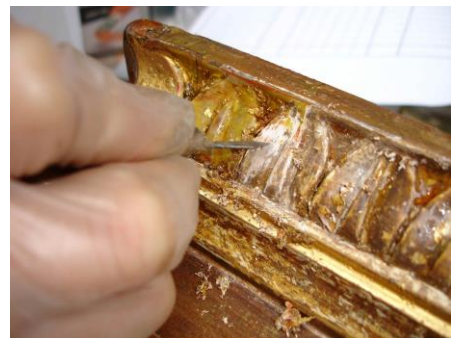
It was extremely difficult to remove the second gilding scheme, which had been applied in very thin layers. Problems also occurred in places where the newer gesso layers were harder than the original softer surfaces, causing some flaking and crumbling of surface.

The overlayers had to be scraped and carved away, using metal spatulas, scalpels and French dragging tools.
