THE USE OF PAINT ANALYSIS TO AID IN THE RESTORATION OF A 17TH CENTURY ITALIAN PAINTED FRAME

By Lucinda Compton

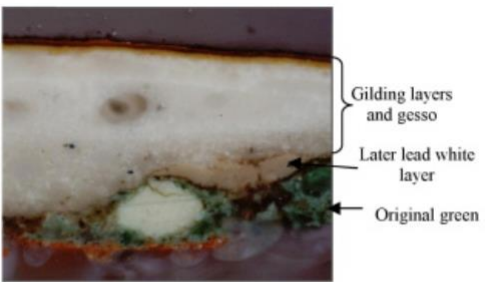
Red lead primer. Original green overlaid by thick gesso and then oil gilding. A trace of plain lead white paint over the green at the right end of the section suggests the frame may have been painted more than once, and that it was cleaned down before the gilding took place. X 200 magnification

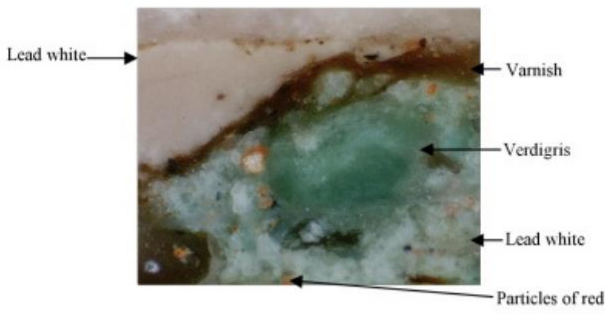
Detail of the green, showing the thick varnish on top, followed by the remains of a white oil paint layer which may have been a second scheme. X 500 magnification.

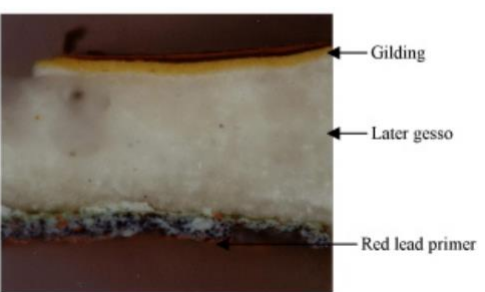
A thin layer of red lead under the purple/blue. X 200 magnification.

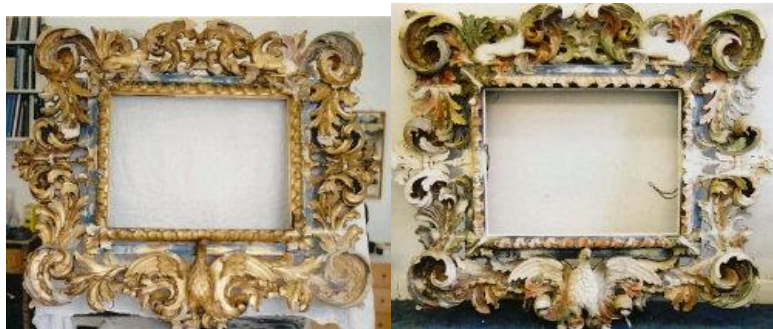
The original colours are wonderfully vibrant and the whole frame is decorated with highlights, lowlights, veins and shading on the leaves, etc. It is a truly stunning and rare frame.

All loose breaks and joints were glued up and supported from behind with canvas and size. All wormholes were treated and filled with glue and sawdust mix so fresh holes can be identified in future (time 10 hours). The hanging attachments were removed and refitted securely. Missing areas of carving were replaced using lime (time 24 hours).

In some areas the gesso and gilt were removed manually by dry-scraping with a Tiranti spatula. This was especially effective above the indigo painted slip frame where the thick layers of loose pigment had prevented the gesso from forming a strong bond. Other areas were extremely stubborn and care was needed to preserve the original paint. The oil gilding was removed with Nitromors. The deep layers of clay and gesso were removed by softening with water soaked papier-mâché, in gradual controlled stages. This was complicated by a huge variation in the thickness of the gesso, and random patches of white lead-based paint.

The loose pigments were consolidated with a barrier layer of Paraloid B72 in toluene.

Areas of bare wood were gessoed and smoothed to match existing thicknesses and then decorated to match the original paint using pigments (as per the analysis) in gum arabic. A thin coat of microcrystalline wax was applied (time 206 hours).
