ANALYSIS AND RESTORATION OF AN ITALIAN CASSONE C. 1400

By Richard Higgins

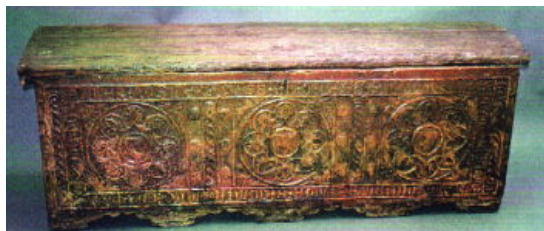
The quality of craftsmanship evident in this piece has obviously contributed to its remarkable state of preservation and, with the exception of the lid, there is only superficial degradation of the gesso rather than large areas of loss and delamination. Gesso made from calcium sulphate was the standard preparation for Italian panels during the Middle Ages and the Renaissance and the method of applying it is famously described by Cennino Cennini in his fourteenth century handbook for painters. According to his instructions, the first coat should be 'gesso grosso' made from unprocessed calcium sulphate, but the final coats should be 'gesso sottile' i.e. using calcium sulphate that was first heated to produce the hemi-hydrate form, then slaked in copious water to form a precipitate of fine particled dihydrate.

The cassone is structurally fairly sound. The back left hand foot is loose and should be secured. Much of the timber around the base is worm damaged but none of the infestation is active. The convex lid has obviously split badly in the past and been filled with an unknown resin. Although somewhat unsightly, this is sound and serves to stabilise effectively the timbers of the lid. The convex surface has at some point started to flatten out and as such is coming away from its side members, particularly at the front. Unless environmental conditions alter radically, then further movement is improbable. Trying to reverse this condition is very likely to cause other damage to the lid and I would therefore recommend that the existing gaps that are evident be accepted as part of the overall character of the piece. It is unfortunate that, because of this movement and extensive worm attack, the vast majority of applied decoration to the lid has been lost.

The cassone is decorated with raised geometric patterns surrounding shields, guarded by winged beasts and the whole is enclosed by a Latin inscription of The Lords Prayer. The background has been textured and patterned using tools to produce tiny crosses and small circles. Unfortunately, the original gilded and coloured decoration has been lost and the cassone over-painted at a much later date with a thin layer of red brown pigment. There is an extensive fungal growth of a cloudy white appearance over the surface of the gesso which has arisen from adverse environmental conditions. Whilst this is fairly firmly attached to the brown paint, it has not yet penetrated deeply into the composition of the gesso.

The only structural work undertaken was to secure the back left hand foot which was loose using traditional scotch animal glue. Surfaces were cleaned prior to gluing using a water based gel. It was necessary to use a fungicidal agent which was not water based as this would cause extensive damage to both the overpaint and the gesso and animal glue. The treatment, however, would need to have a low viscosity in order to penetrate below the surface. We applied IMS (95% ethanol: 5% methanol) with cotton wool swabs which would instantly kill mould spores, flow into surface cracks and evaporate quickly without leaving harmful chemical residues. The entire surface and interior was treated and the growth removed. A surprisingly small amount of surface dirt came away.

Subsequently a dilute mixture of paraloid B72 crystals, (B72 20%: Propanone 70%: IMS 10%) was prepared for consolidation of the gesso. Using the same method of application, the brown surface was then wiped down with Propanone/IMS during the process to leave it free of consolidant. Paraloid was chosen because it is easily removable using its carrying agent so that, should future conservators wish to carry out further excavations of the painted surface, they can do so easily and without damage.

Finally, a light coating of microcrystalline wax was applied in order to further protect the surface and revive the red/brown pigment.
