CRAMPING OF RISEN TABLE TOP VENEER

By Michael Barrington

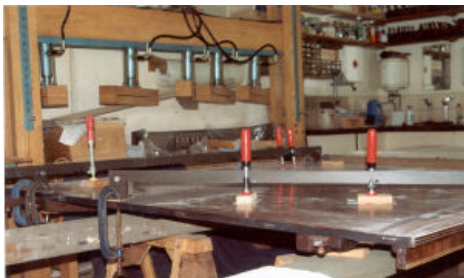
Because of the hard use this table experiences, table-top polish and its solvent, applied conventionally with a rubber was used and this was compatible with the former/original layers. The owners were warned of this in advance but had no concerns and were enthusiastic that a hard and more ring resistant type of finish was to be used. The centre areas of the five inner leaves showed signs about 2ft wide of having carried heavy silver centre pieces and candelabra, in that they bore a multitude of score marks and indentations. But such is the quality of the plywood substrate, this damage, except for one small area was veneer deep only and was easily concealed during polishing.

Putting down the bubbles was the first job and had to be done without altering the consistently pale colour of the rosewood. The first thing we did was a trial run on bubbles close enough to the edge to enable us to use standard bar cramps. MDF 22mm cauls of various sizes, faced with melamine were made. These will not stick to the surface and MDF and melamine are good heat sinks. Some of the bubbles went straight down after a cramping time of about three hours, while others were obstinate and took two 'goes'. More obstinate ones had to have the bubbles split with a very sharp craft knife, hot glue was puddled on and a hot caul cramped to drive in the glue. We also encouraged the molten glue to penetrate by bouncing a plastic car window squeegee on the surface like a drain plunger. The squeegees can be bought in motor accessory shops in packets of four; they were popular at the time of England's disastrous efforts in the World football for supporting St George flags on vehicles. The whole operation of putting down the bubbled veneers lasted two weeks with cutting back and re-polishing being done in tandem as each leaf was finished.
