ANALYSIS AND RESTORATION OF AN ITALIAN CASSONE C. 1400

By Richard Higgins

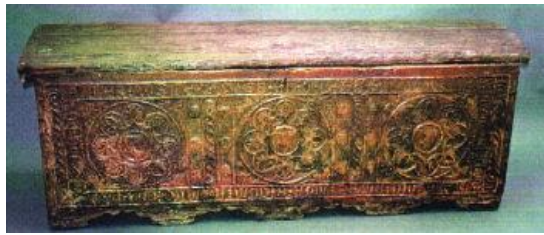
The quality of craftsmanship evident in this piece has obviously contributed to its remarkable state of preservation and, with the exception of the lid, there is only superficial degradation of the gesso rather than large areas of loss and delamination. Gesso made from calcium sulphate was the standard preparation for Italian panels during the Middle Ages and the Renaissance and the method of applying it is famously described by Cennino Cennini in his fourteenth century handbook for painters. According to his instructions, the first coat should be ‘gesso grosso’ made from unprocessed calcium sulphate, but the final coats should be ‘gesso sottile’ i.e. using calcium sulphate that was first heated to produce the hemi-hydrate form, then slaked in copious water to form a precipitate of fine particled dihydrate.

The cassone is structurally fairly sound. The back left hand foot is loose and should be secured. Much of the timber around the base is worm damaged but none of the infestation is active. The convex lid has obviously split badly in the past and been filled with an unknown resin. Although somewhat unsightly, this is sound and serves to stabilise effectively the timbers of the lid. The convex surface has at some point started to flatten out and as such is coming away from its side members, particularly at the front. Unless environmental conditions alter radically, then further movement is improbable. Trying to reverse this condition is very likely to cause other damage to the lid and I would therefore recommend that the existing gaps that are evident be accepted as part of the overall character of the piece. It is unfortunate that, because of this movement and extensive worm attack, the vast majority of applied decoration to the lid has been lost.

The only structural work undertaken was to secure the back left hand foot which was loose using traditional scotch animal glue. Surfaces were cleaned prior to gluing using a water based gel. It was necessary to use a fungicidal agent which was not water based as this would cause extensive damage to both the overpaint and the gesso and animal glue. The treatment, however, would need to have a low viscosity in order to penetrate below the surface. We applied IMS (95% ethanol: 5% methanol) with cotton wool swabs which would instantly kill mould spores, flow into surface cracks and evaporate quickly without leaving harmful chemical residues. The entire surface and interior was treated and the growth removed. A surprisingly small amount of surface dirt came away.
