**RESTORATION REPORT FOR
THE GRAND MASTER'S THRONE
AND A PAIR OF WARDEN'S
CHAIRS
PROPERTY OF THE UNITED
GRAND LODGE OF ENGLAND
By Ray Dudman
a BAFRA Accredited Member**

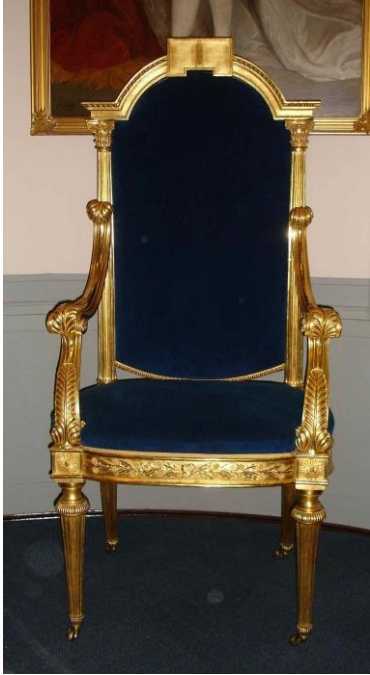
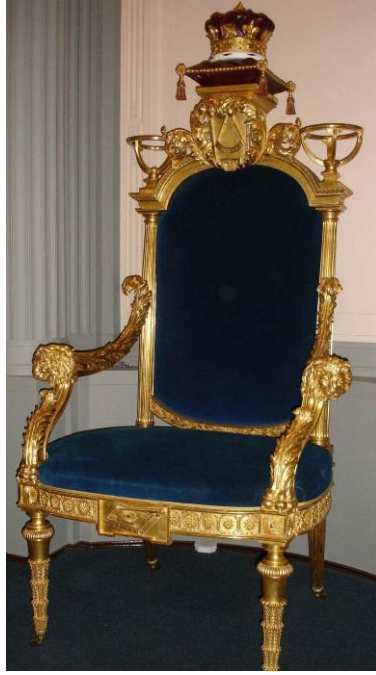
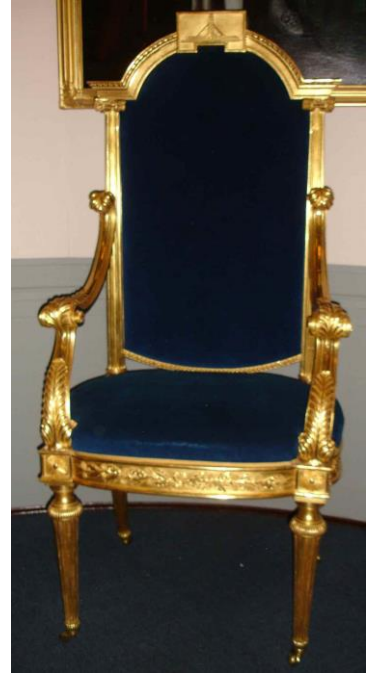
The two globes are not fitted to the Master's Throne (Centre)

The chairs were then completely re-assembled and calico dust covers made to fit each chair.
