THE USE OF PAINT ANALYSIS TO AID IN THE RESTORATION OF A 17TH CENTURY ITALIAN PAINTED FRAME

By Lucinda Compton

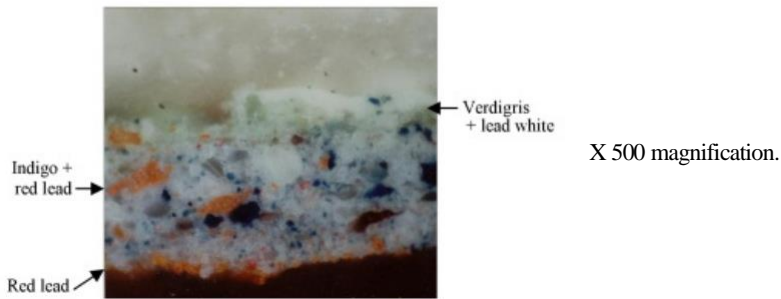
The Green is a mixture of coarsely ground verdigris (copper acetate) and lead white. The Blue is indigo. Pink - a mixture of red ochre and lead white, Red – vermilion and red lead, Purple – a mixture of vermilion, indigo and lead white. These pigments are all historically correct for the date. In sample 1B we can see the remains of the original resin varnish. Above this are remains of a layer of white oil paint indicating the frame was painted before being sanded down prior to applying the thick layers of gesso and gold.
